INSPECTION REPORT

For the Property at:
112 EVANS
TORONTO, ON

Prepared for: BENITA MOORE
Inspection Date: Friday, October 12, 2007

Report No. 1329

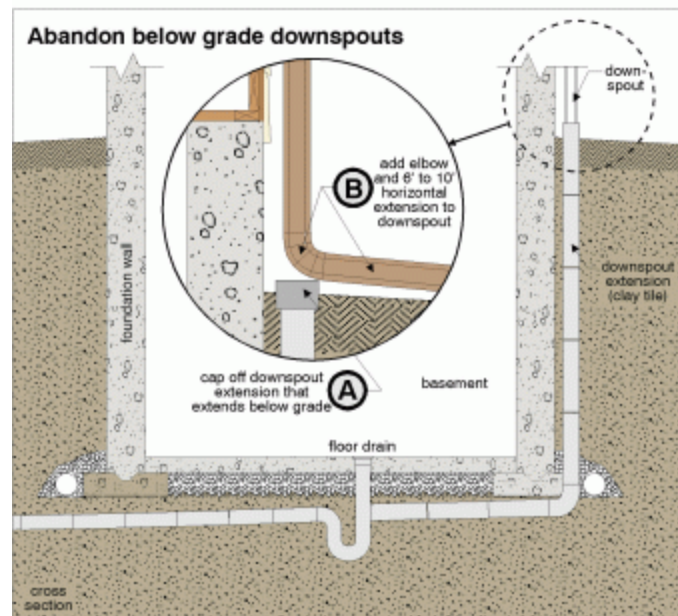
Roof drainage \ Downspouts

Condition: • [Downspouts discharging below grade](#)

Location: Various

Task: Improve

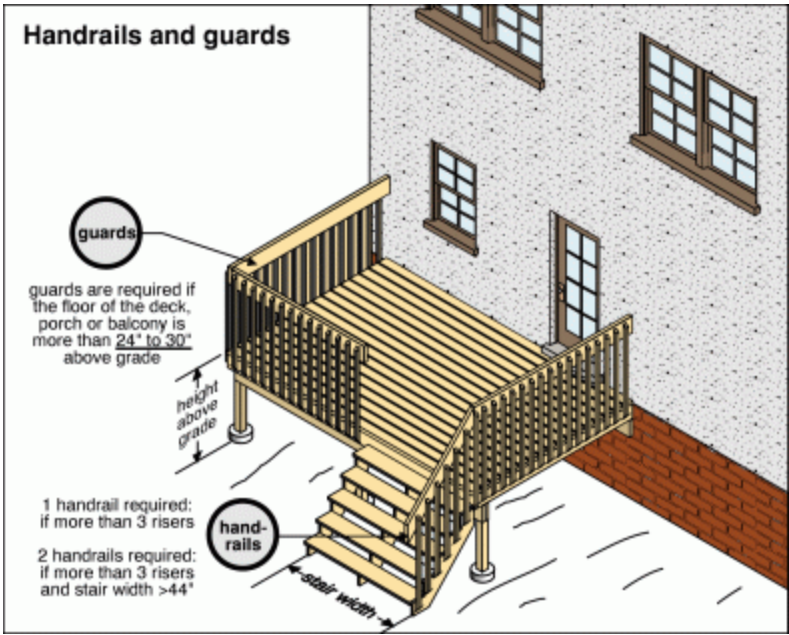
Porches, decks, steps, patios and balconies \ Handrails and guards

Condition: • [Missing](#)

Location: Rear

Task: Provide

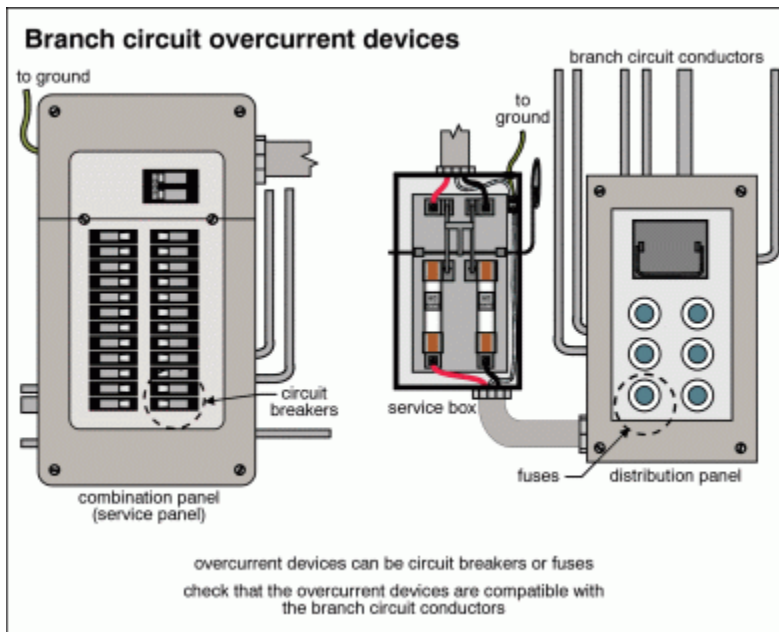
Service box, grounding and panel \ Distribution fuses/breakers

Condition: • [Fuses or breakers too big](#)

Location: Basement

Note: Fuses at third fuse block from top are too big for circuit. Fire hazard

Task: Replace

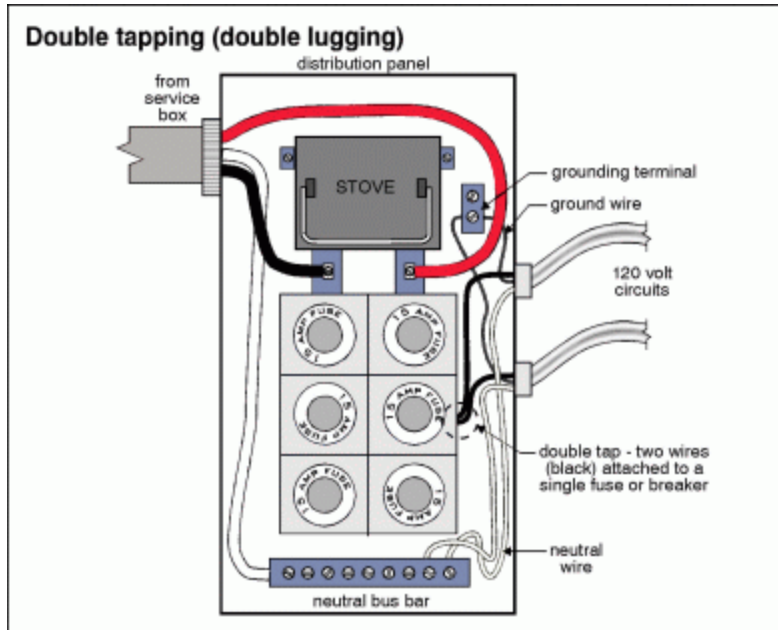
Service box, grounding and panel \ Panel wires

Condition: • [Overheating](#)

Note: At lowest right side.

Condition: • [Double taps](#)

Task: Correct

Task: Improve

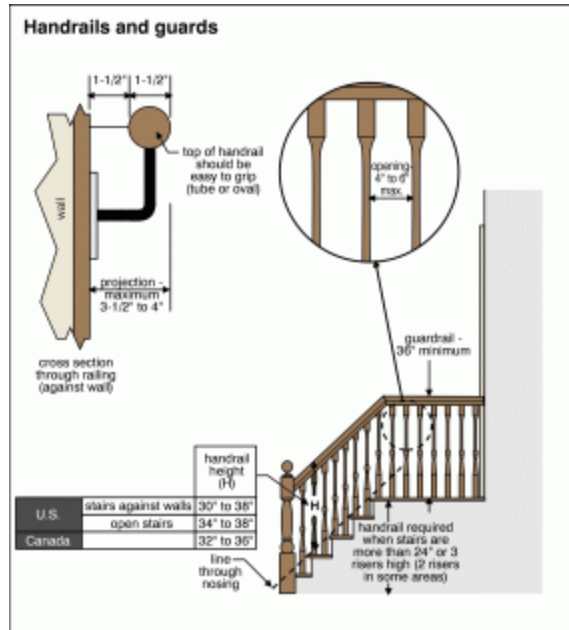
Stairs \ Handrails

Condition: • [Missing](#)

Location: Basement

Task: Provide
