**AmeriSpec of Toronto West & Mississauga Report**

Client: Royal LePage Real Estate Services      Inspection No: 200903-00098  
 Address: 29 Burnhamthorpe Park Blvd.      Inspection Date: 3/6/2009  
           Toronto, ON M9A 1H8  
 Inspector: Roger Orvis

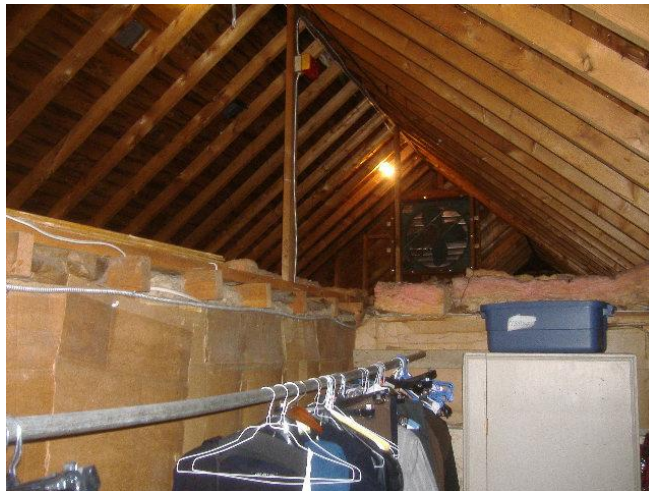
Attic access is located at the master bedroom closet.

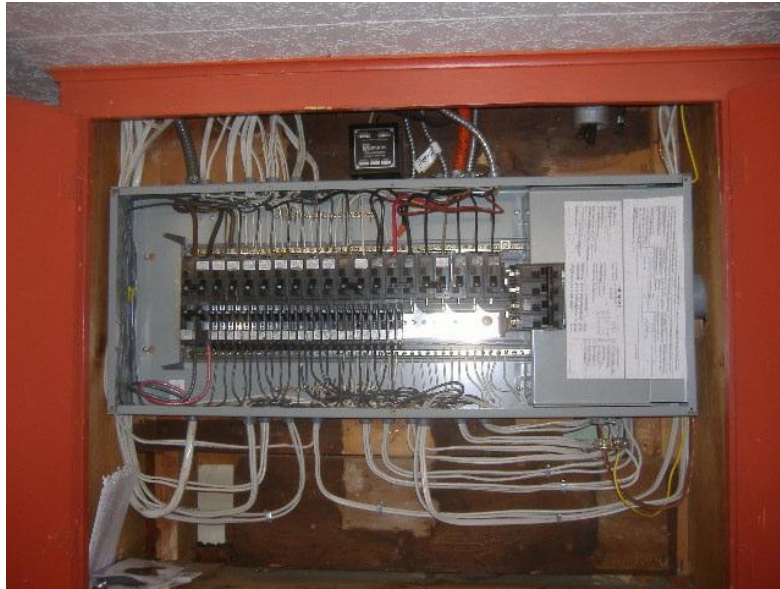
The main electrical panel was located at the right basement. Overload protection of the main electrical service wires is provided by breakers. Main disconnect noted. The system appears to be properly grounded.
