AmeriSpec of Toronto West & Mississauga Report

Client: Royal LePage Real Estate Services Inspection No: 200808-00602
 Address: 29 Mapleview Avenue Inspection Date: 8/8/2008
 Toronto, ON M6S 3A6
 Inspector: Roger Orvis

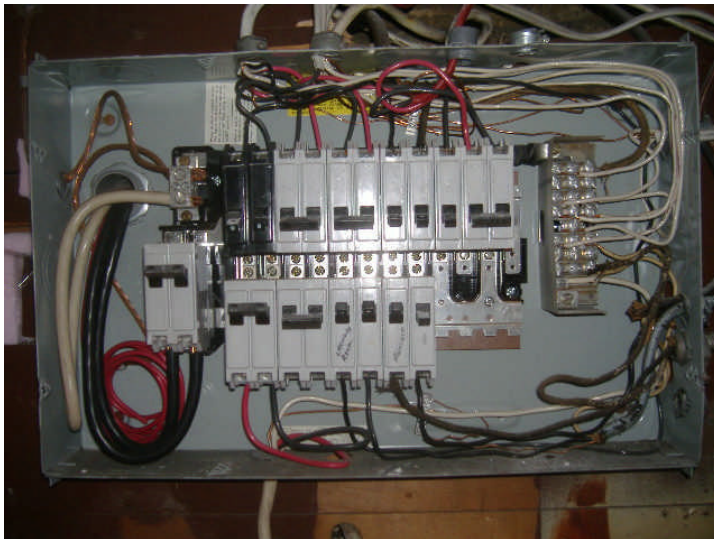
The main electrical panel was located at the right basement. Overload protection of the main electrical service wires is provided by breakers. Main disconnect noted. The main conductor is copper. The system appears to be properly grounded.
