# INSPECTION REPORT

For the Property at:  
**43 ARDAGH STREET**  
TORONTO, ON

Prepared for: BENITA MOORE  
Inspection Date: Wednesday, October 17, 2007  
Prepared by: Sheila Corman

RE: Report No. 1332  
43 Ardagh Street  
Toronto, ON

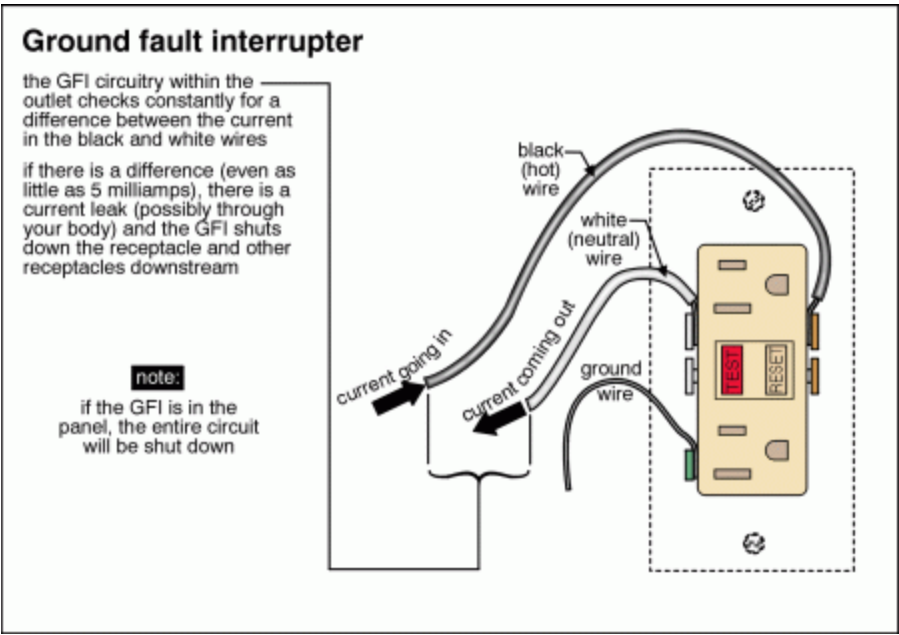
### Distribution system \ Outlets

**Condition:** • [No GFI](#)

**Location:** Bathroom and kitchen counter

**Task:** Provide

**Time:** Immediate

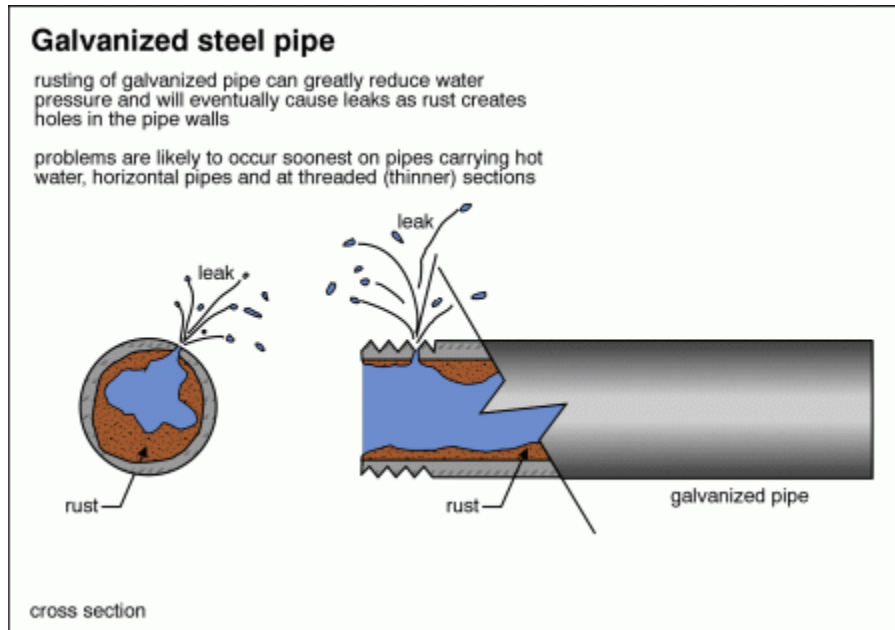
**Condition:** • [Galvanized steel](#)

**Location:** Basement

**Note:** Galvanized steel supply pipe may be an insurance issue. Recommend replacement of any that still exists. A short section was visible in basement.

**Task:** Replace

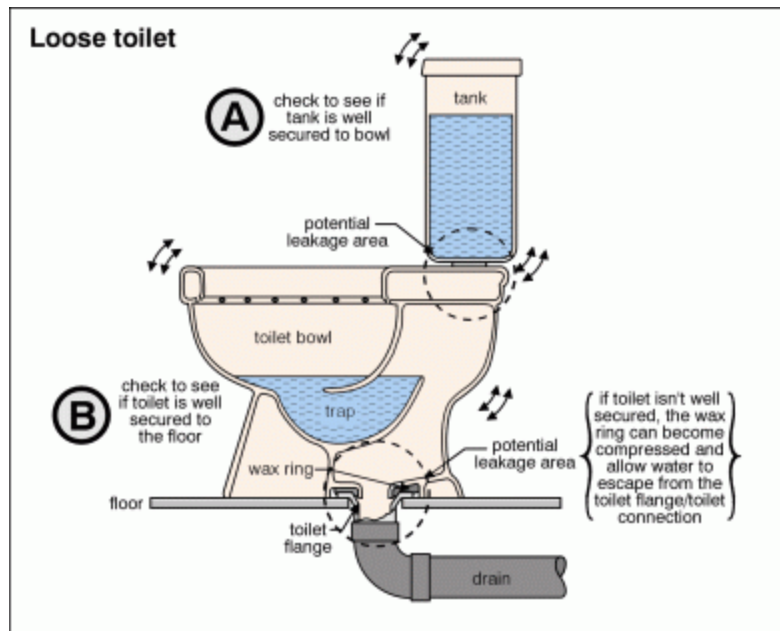
## Fixtures and faucets \ Toilet

Condition: • [Loose](#)

Location: Second floor Bathroom

Task: Improve

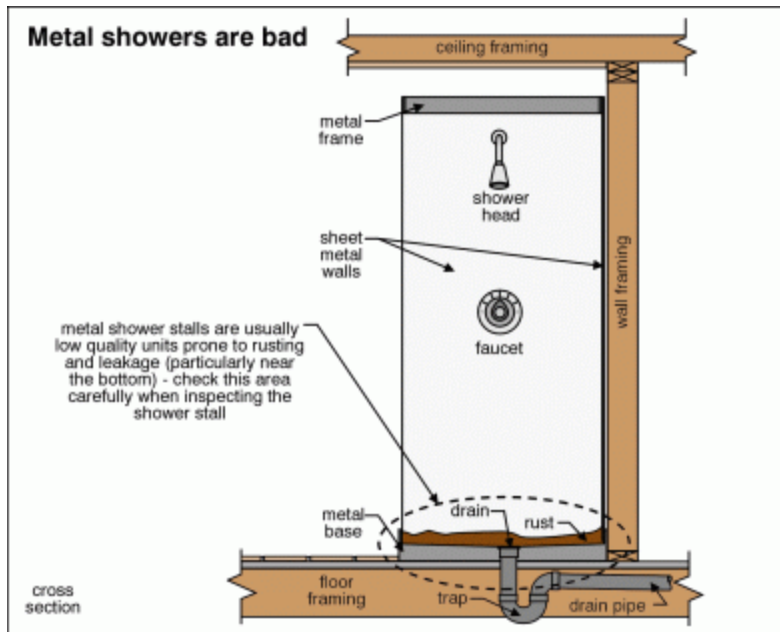
## Fixtures and faucets \ Shower stall

Condition: • [Rust](#)

Location: Basement

Task: Replace

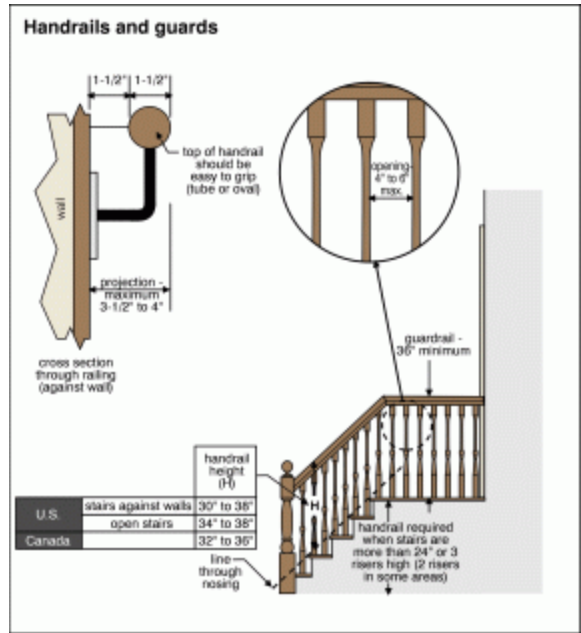
### Stairs \ Handrails

**Condition:** • [Missing](#)

**Location:** Basement

**Task:** Provide
